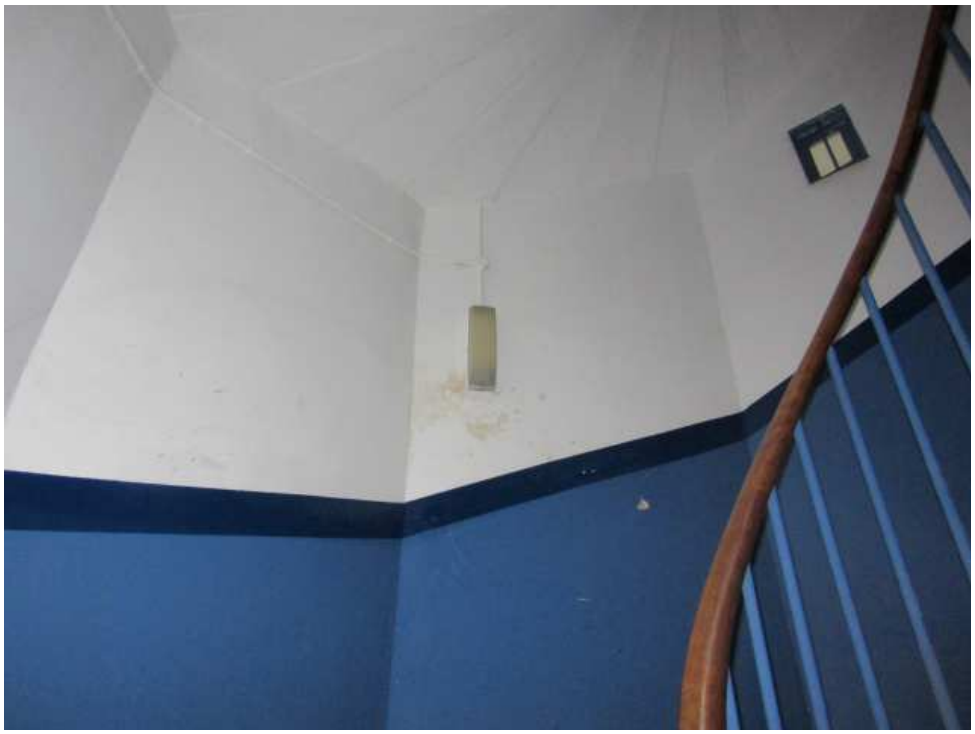
LOCATION: Mutual Stair well

Measurements	°C
Sp1	13.5
Sp2	13.2
Sp3	11.7
Sp4	12.1
Sp5	11.8

Dampness in the hard plaster on the walls. Note the dampness in behind the wiring of the hall light. This could prove to be a Fire Hazard!
